SPECIAL REPORT

Inmate Services and
Conditions of Custody in
Saskatchewan
Correctional Centres

October 2002

Regina Correctional Centre

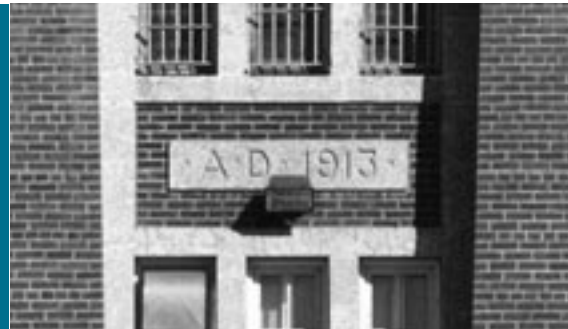
In 1913, there was a strong emphasis on isolation and supervision...the designs of the buildings that make up the main complex do not support current corrections philosophy and arguably work against it.

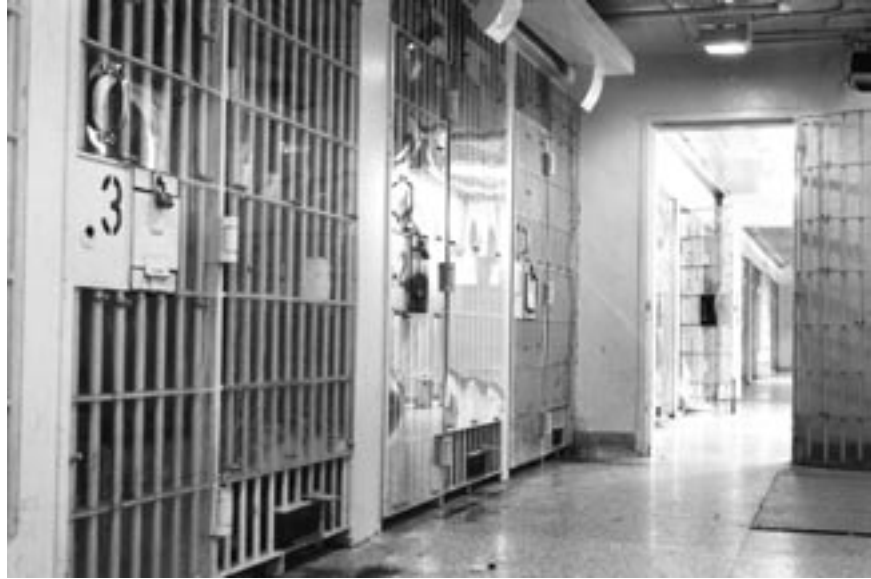
Staff interaction with inmates is an integral part of Corrections' rehabilitative plan. In Unit 1, the opportunities for interaction are limited. For security purposes, two staff members supervise one side of each level of cells. Once every hour, one of the workers walks down the unit to make sure everything is okay inside the cells, while the other waits at the end gate in case anything happens.

The corrections worker walking the corridor could talk to inmates, but the barred cells and narrow corridor leave little room for private conversations.

+ Bring the Main Complex of the Regina Correctional Centre up to current building standards or build a new facility.

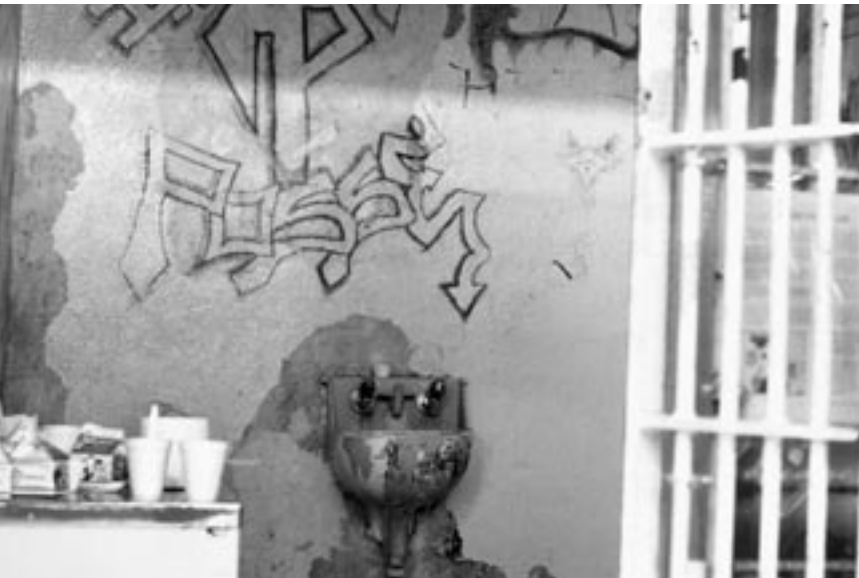
stairs so staff occupy one of the offices on the other side and watch inmates remotely through video monitors. Once every hour, one of the two staff members who supervise this unit walks down each corridor, while the other stands at the end. In these circumstances, there is almost no interaction between staff and inmates and staff are limited in their ability to supervise the inmates. The video monitors do not permit a clear view of the end of each unit, and trying to watch three video monitors quickly results in fatigue. There is the added problem that when staff members are walking the corridors, two of the units are unsupervised. We commonly get complaints from remand inmates that they are being threatened or bullied by other inmates. The centre is aware of the problem, but short of building a new facility is limited in its ability to resolve it.

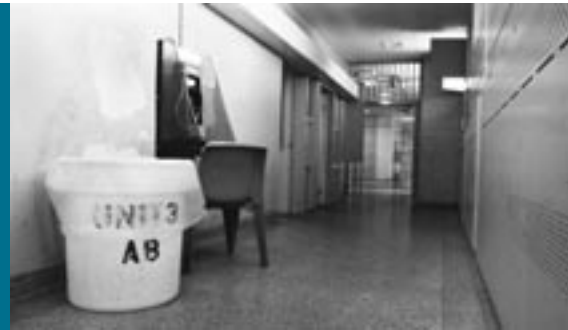
A closer examination reveals a facility that no longer meets acceptable standards. Rather than assisting Corrections' rehabilitative efforts, the facility hinders them.
